# HAZARD ALERT

## Metal Awning Collapse 28 February 2022

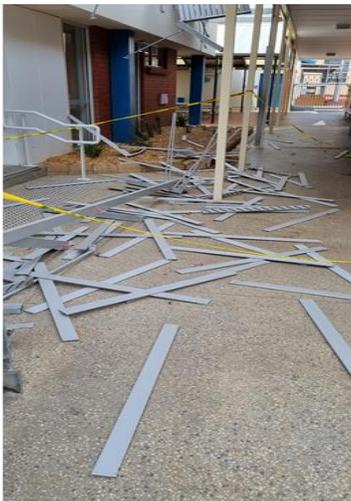
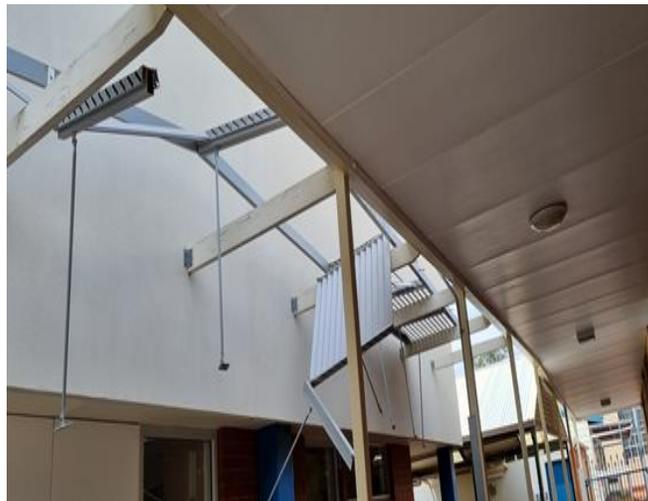
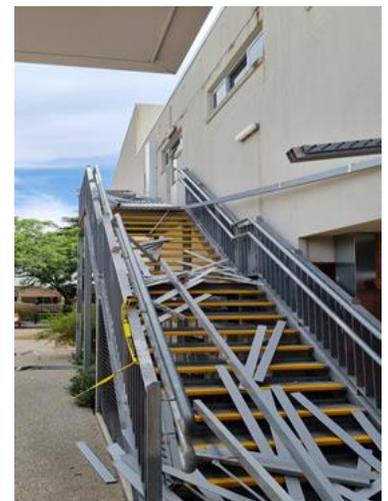
Recently an incident occurred where a metal awning became detached and fell from the second storey of a building during a weather event. The area underneath the awning is usually a busy thoroughfare, however it occurred on a Sunday when there was no one present in the direct vicinity.

Remnants of the collapsed metal awning

- Identify whether your site has any metal awning structures similar to this. They are generally found above windows and/or entrances. If similar structures are found on your site, please add them to your Grounds, Buildings, and External Walkways Workplace Inspections Form.

- Inspect whether any of the upper supports have pulled away from the building, come loose or are severely corroded.
- Inspect where the wall plate of the structure is fixed to the building and check to see it is still secure and not pulling away from the wall or its fixing points.

- If there are any issues present, prevent access to the direct area underneath and contact your building maintenance provider immediately for further inspections or repairs.

- When installing overhead structures only use qualified builders and certified products.
- **For enquiries or further information please contact your WHS Consultant at CSHWSA**
